BUILDING DATA / RECEIPT INFORMATION

Inspection Date: 3.18.05
Inspection Number: 2154
Client Name: Client Name
Inspection Address: Somewhere Important near Seattle
Inspected by: Neal Johnson

Approximate Age: 23 years
Style: One story
General Appearance: Satisfactory
Main Entrance Faces: East
Weather Condition: Clear
Temperature: 54 degrees
Ground cover: Damp

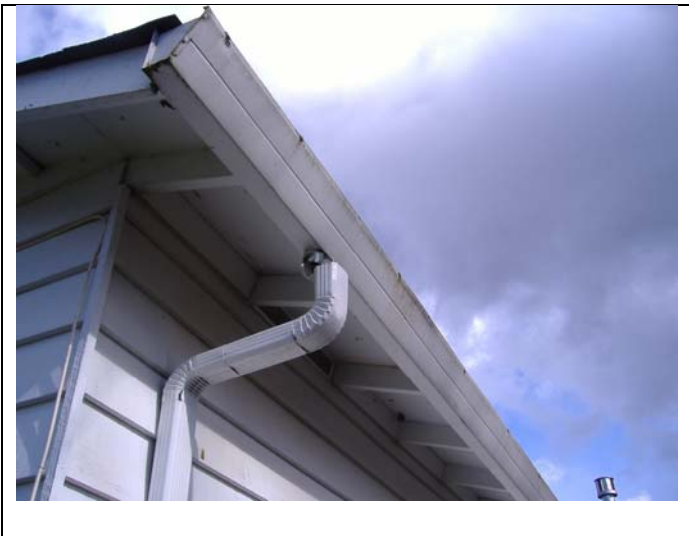
Downspout disconnected.

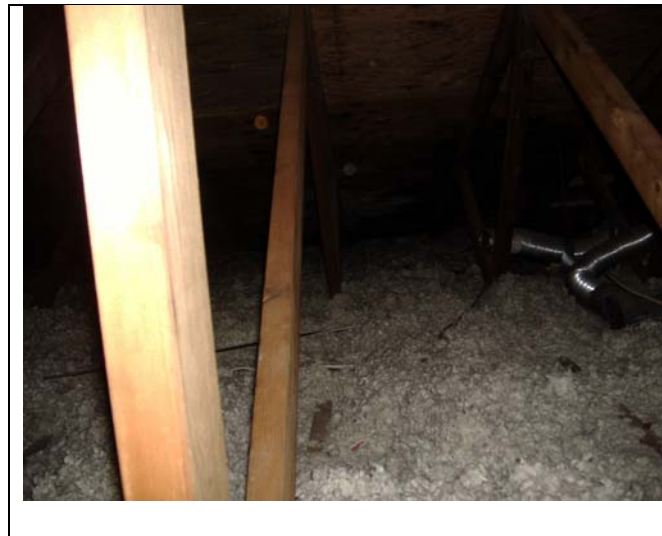
- M1. We would recommend that all plants that touch the home be trimmed back to avoid damage to paint seals, siding products, etc...
- M2. We recommend that all cracks in service walks and driveways be properly filled and sealed to prevent further damage.
- M3. There is moss growing on the sheds roof covering. We recommend this moss be chemically treated and removed.
- M4. We would recommend caulk be applied to ensure a watertight barrier at the following locations: Caulk around the hall bath tub spigot, and the upper rim of the master bathroom shower rim.
- M5. There is a gutter downspout disconnected in the SW corner. We recommend it be reattached.
- M6. The bathroom fans vent tubes in the attic are not connected to a vent. We recommend they be attached.

Bathroom vent tubes lying in insulation.

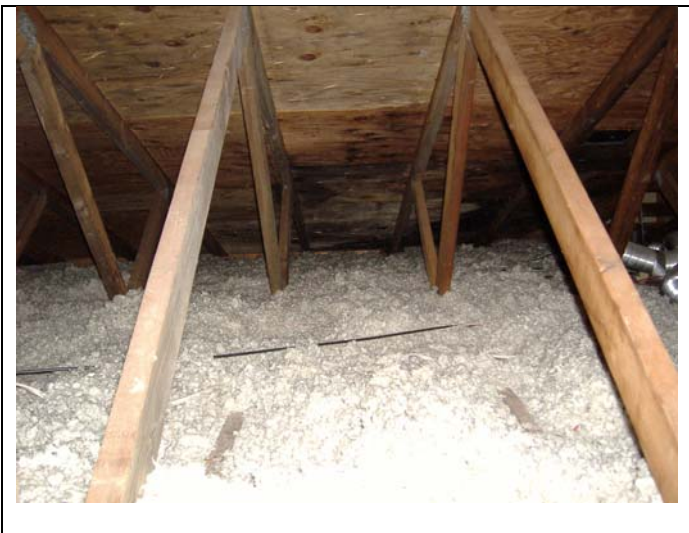
- D1. The roof sheathing shows signs of damage/stains from previous leaking. We recommend a licensed roofing contractor come and look at this roof sheathing to determine the extent of repairs needed, if any, determine the estimated cost of these repairs, and the estimated remaining life left in this roof sheathing.

Sheathing discoloration.

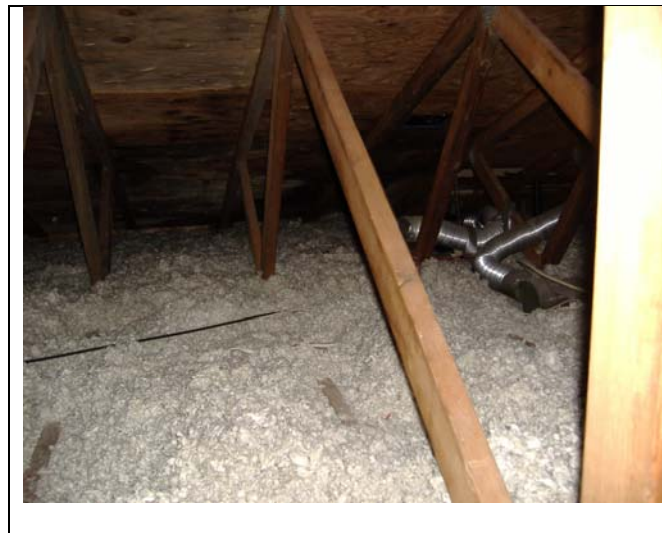
Discoloration, possible damage.
